2011 Vegetation Monitoring Program Observation Monitoring Sites and Livestock Grazing Summary for the Kern Water Bank

2011 VEGETATION MONITORING PROGRAM
OBSERVATION MONITORING SITES AND LIVESTOCK GRAZING SUMMARY
for the
KERN WATER BANK

**KERN WATER BANK
OMS LOCATIONS**

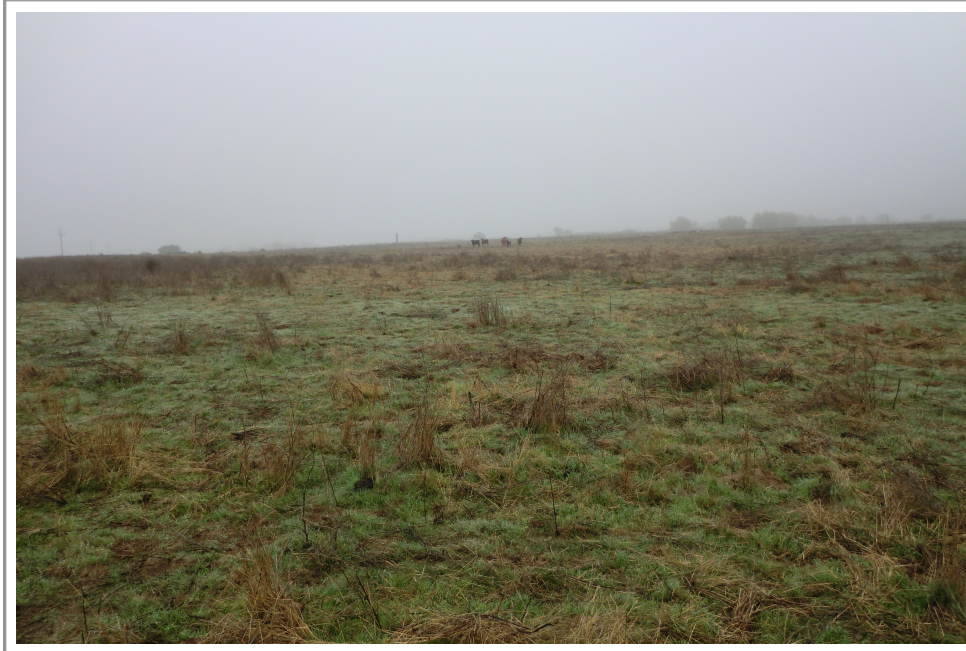
Most of the recharge areas were not able to have cattle turned out in any significant numbers until later in the season. As a result, there was still significant growth of vegetation in most areas even into the late fall as indicated in Photograph 1. Additionally, above-normal rains in October and November led to abundant new germination and early growth of vegetation as well. Cattle were increased on all areas of the KWB recharge in the late fall when conditions allowed. With most of the recharge basins still holding water at the end of the year, cattle grazing was primarily occurring within the Compatible Habitat areas in 2011 (Photograph 2).

Photograph 1. Area of Compatible Habitat within the Recharge Area on KWB on November 29, 2011. Note the abundant growth from the 2011 season and new growth from the significant early rains.

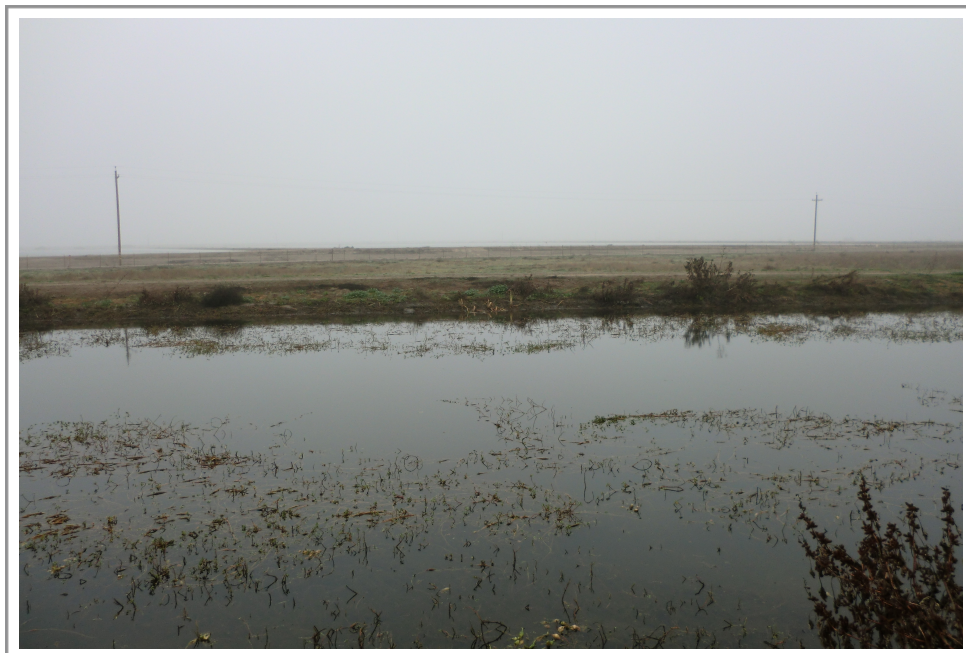
Photograph 2. Most of the recharge basins and canals were flooded in December 2011 and into 2012.

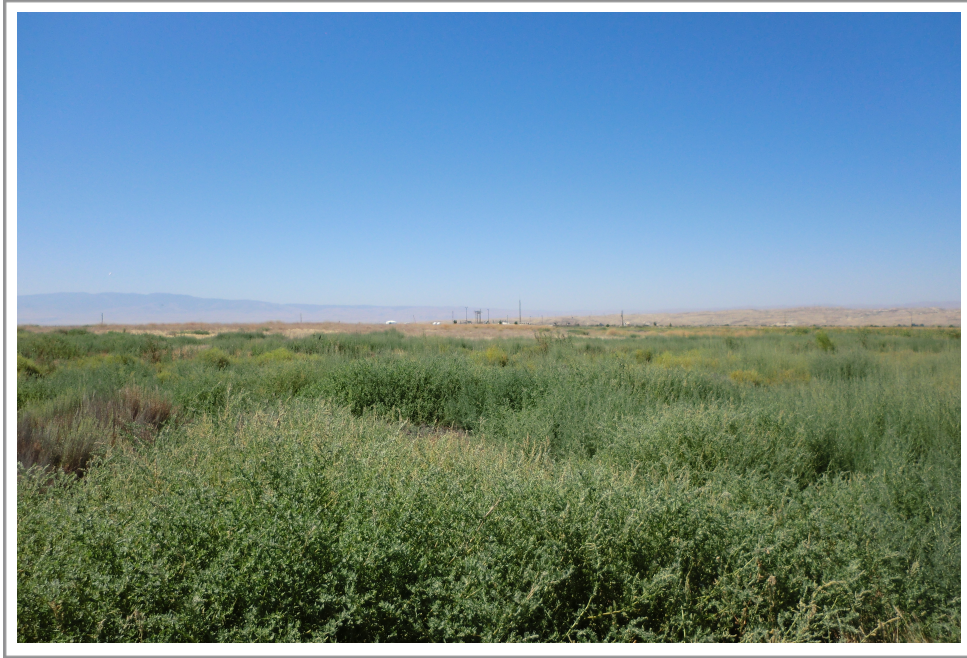
Photograph 3. Compatible Habitat area within the Main Area showing the effects of opportunistic plants such as five-hook bassia at exploiting the abundant shallow ground water adjacent to a recharge basin.

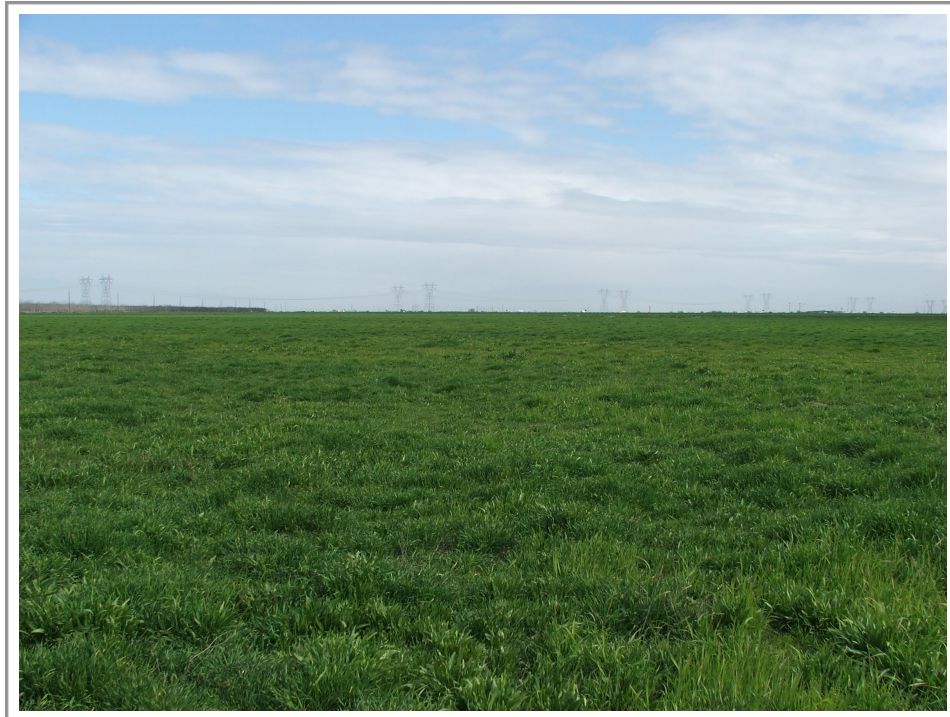
Photograph 4 illustrates the conditions within the South Area in late January of 2011. Abundant germination and growth of non-native grasses and forbs had already progressed to a point that necessitated turning cattle out earlier than was originally planned. Cattle were turned out in the South Area in February in an effort to begin managing the abundant growth. The target RDM (approx. 500 lbs. per acre), was reached in mid-July and the process of removing cattle from the South Area and onto

Photograph 4. Rapid germination and growth of herbaceous cover was observed in the South Area (Conservation Bank) in late January 2011. Cattle were turned out in February to begin to manage the abundant growth and begin the process of reducing cover to the target RDM of approx. 500 lbs. per acre.

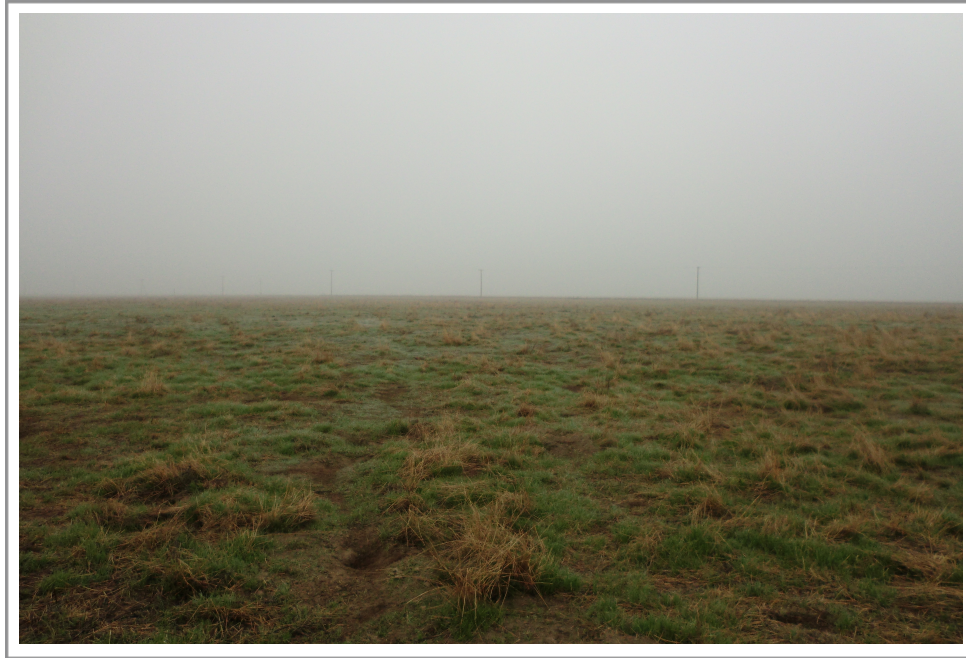
other areas of the KWB was initiated in late July and early August. Numerous active kangaroo rat burrows were observed during the third and fourth quarter monitoring visits to OMS 7 and other locations within the South Area in 2011. Photograph 5 illustrates the conditions observed in November 2011 at OMS 7.

Photograph 5. Vegetation conditions in the South Area in late November 2011. The new green growth was in response to significant early rainfall in October and November. Prior to this new growth, RDM was approx. 500-600 lbs. per acre.

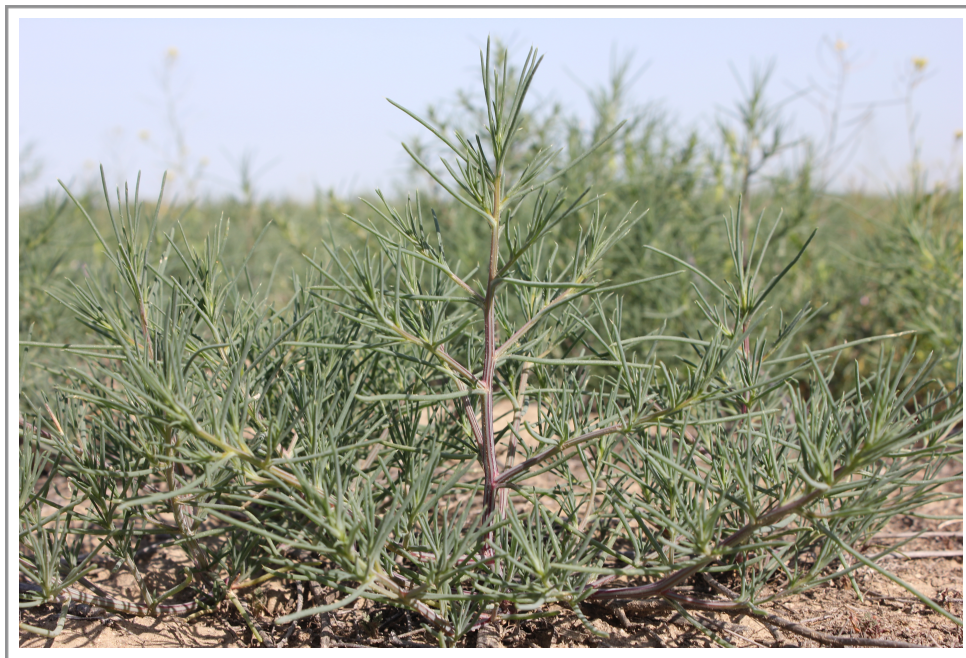
Photograph 6. Rapidly growing Russian thistle plant in response to late season rains within the Strand Area. Photograph was taken on May 2, 2012. The plant is about 10 inches in height. Cattle will still eat plants at this developmental stage, but they will not seek it out as it is becoming unpalatable and there are more palatable species in the area.

The recharge areas, especially the Main, West, and Strand areas are currently being grazed in an effort to attempt to control abundant Russian thistle growth in some of the recharge basins and in the Compatible Habitat areas in the West and Strand areas. Unfortunately, although the 2011 - 2012 rain season has been dry, two strong storms in mid-April have appeared to result in significant growth of Russian thistle in many areas, especially in traditionally troublesome locations within the Strand, West, and James areas (Photograph 6). Unfortunately, the plants have grown rapidly and the cattle will probably only have a limited effect at thinning the plants before the plants become unpalatable. It is clear that while livestock grazing is the primary tool for managing vegetation on the KWB, it is also clear that its effectiveness can be limited in the highly variable and unpredictable nature of our climate, especially in regards to the amount and timing of seasonal precipitation.

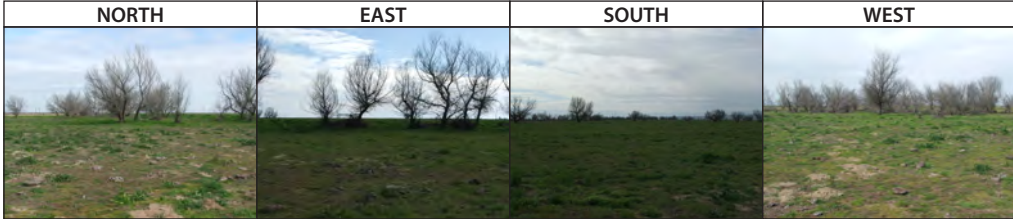
1ST QUARTER	<p>SURVEY DATE: 02/14/2011 TIME: 10:00 AM MONITOR(S): J. JONES, S. JONES RAINFALL TO DATE: 0.89 IN WIND DIRECTION: SE WIND VELOCITY: 5 MPH TEMPERATURE: 60 F HUMIDITY: 42%</p> <p>NOTES: SEVERAL ACTIVE K-RAT BURROWS WILDLIFE PRESENT: GREAT BLUE HERON PLANTS PRESENT: AMSINCKIA MENZIESII, BROMUS RUBENS, CAPSELLA BURSA-PASTORIS, ERODIUM CICUTARIUM, HIRSCHFELDIA INCANA, MALVA PARVIFLORA, PLAGIOBOTHRYSP., SALIX GOODDINGII, SENECIO VULGARIS, SISYMBRIUM IRIIO, VULPIA MYUROS</p>	NORTH	EAST	SOUTH	WEST

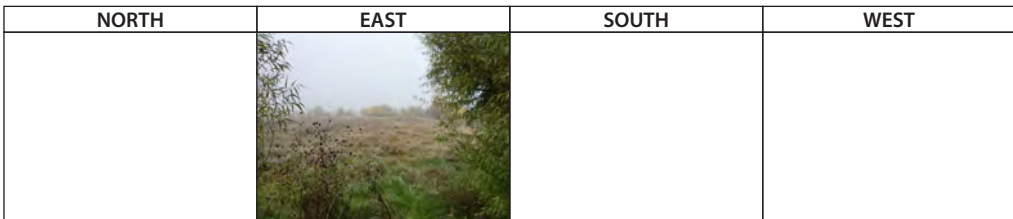
4TH QUARTER	<p>SURVEY DATE: 11/29/2011 TIME: 9:15 AM MONITOR(S): J. JONES, S. JONES RAINFALL TO DATE: 4.39 IN WIND DIRECTION: WIND VELOCITY: 0 MPH TEMPERATURE: 55 F HUMIDITY: 70%</p> <p>NOTES: FLOODED WILDLIFE PRESENT: WHITE-CROWNED SPARROW PLANTS PRESENT: BROMUS RUBENS, CYNODON DACTILION, JUNCUS BALTICUS, LACTUCA SALINA, RUMEX CRISPUS, SALIX GOODDINGII</p>	NORTH	EAST	SOUTH	WEST

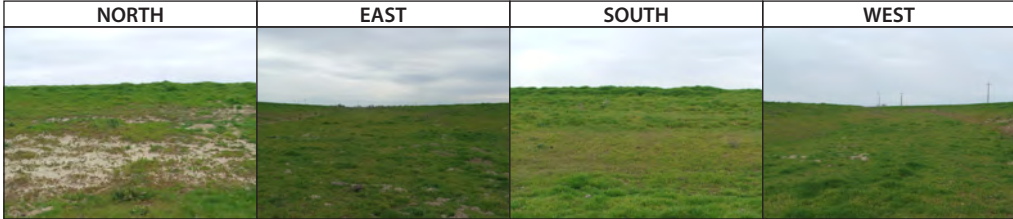
1ST QUARTER	<p>SURVEY DATE: 02/14/2011 TIME: 11:32 AM MONITOR(S): J. JONES, S. JONES RAINFALL TO DATE: 0.89 IN WIND DIRECTION: WIND VELOCITY: 0 MPH TEMPERATURE: 63 F HUMIDITY: 35%</p> <p>NOTES: WILDLIFE PRESENT: CALIFORNIA GROUND SQUIRREL, GOPHER, LOGGERHEAD SHRIKE PLANTS PRESENT: AMSINCKIA MENZIESII, BROMUS RUBENS, ERODIUM CICUTARIUM, HIRSCHFELDIA INCANA, RUMEX CRISPUS, SISYMBRIUM IRIO</p>	NORTH	EAST	SOUTH	WEST

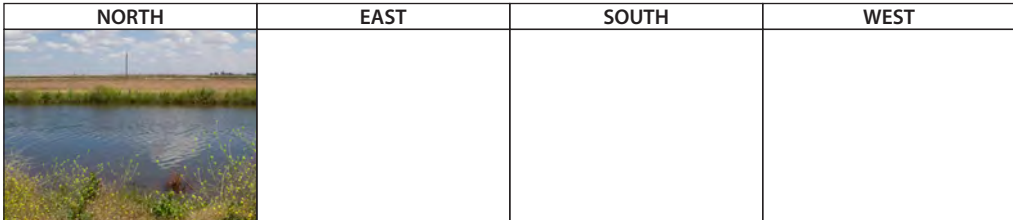
2ND QUARTER	<p>SURVEY DATE: 06/02/2012 TIME: 11:41 AM MONITOR(S): J. KANG RAINFALL TO DATE: 3.08 IN WIND DIRECTION: NW WIND VELOCITY: 2 MPH TEMPERATURE: 65 F HUMIDITY: 31%</p> <p>NOTES: FLOODED WILDLIFE PRESENT: COMMON RAVEN PLANTS PRESENT: AMSINCKIA MENZIESII, BROUMS RUBENS, SISYMBRIUM IRIO</p>	NORTH	EAST	SOUTH	WEST

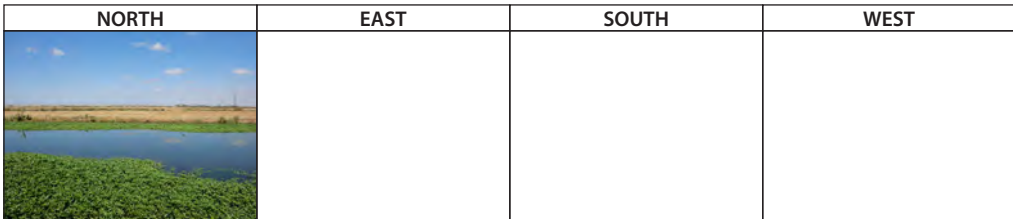
3RD QUARTER	<p>SURVEY DATE: 09/26/2011 TIME: 1:23 PM MONITOR(S): J. JONES, S. JONES RAINFALL TO DATE: 3.08 IN WIND DIRECTION: S WIND VELOCITY: 3 MPH TEMPERATURE: 85 F HUMIDITY: 40%</p> <p>NOTES: FLOODED, WATER HYACYNTH WILDLIFE PRESENT: COMMON RAVEN, MALLARD, REDTAIL HAWK, TURKEY VULTURE PLANTS PRESENT: CONYZA CANADENSIS, CYPERIA SP., LUDWIGIA PEPLOIDES, RUMEX CRISPUS, XANTHIUM STRAMANTHIUM</p>	NORTH	EAST	SOUTH	WEST

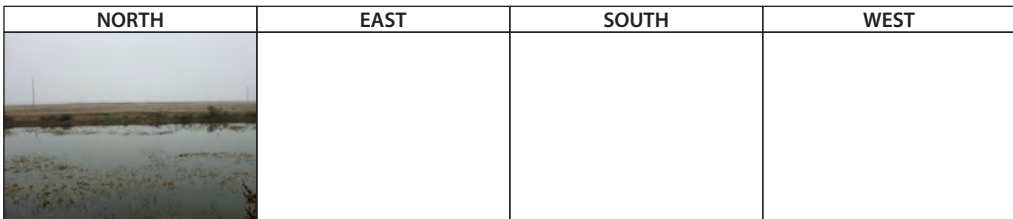
4TH QUARTER	<p>SURVEY DATE: 11/29/2011 TIME: 9:30 AM MONITOR(S): J. JONES, S. JONES RAINFALL TO DATE: 4.39 IN WIND DIRECTION: W WIND VELOCITY: 2 MPH TEMPERATURE: 56 F HUMIDITY: 65%</p> <p>NOTES: FLOODED, WATER HYANCYNTH WILDLIFE PRESENT: AMERICAN COOTS PLANTS PRESENT: CONYZA CANADENSIS, HIRSCHFELDIA INCANA, LUDWIGIA PEPLOIDES, MALVA PARVIFLORA, RUMEX CRISPUS, XANTHIUM STRIMARIUM</p>	NORTH	EAST	SOUTH	WEST
