### 2014 Vegetation Monitoring Program Observation Monitoring Sites and Livestock Grazing Summary for the Kern Water Bank

# 2014 Vegetation Monitoring Program Observation Monitoring Sites and Livestock Grazing Summary for the KERN WATER BANK

June 3, 2015

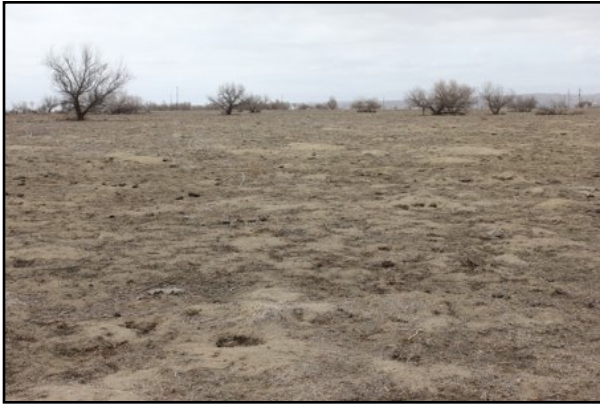
**Photograph 1.** Pond basin in Strand Area on March 7, 2014. No visible herbaceous growth.

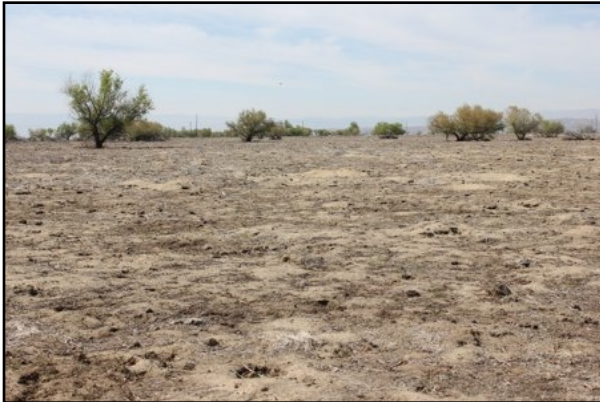
**Photograph 2.** Same area as shown in Photograph 1 on April 9, 2014. Only the trees show any growth.

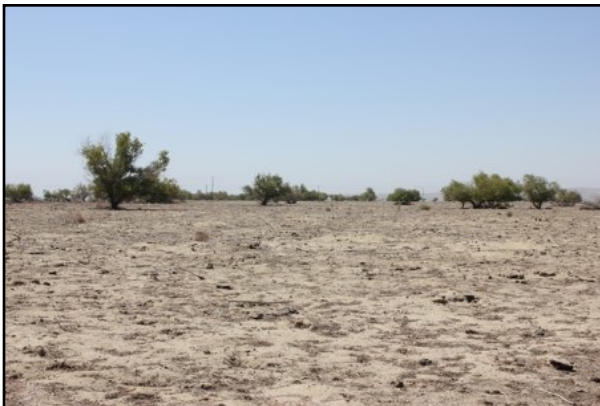
**Photograph 3.** Same area as shown on September 9, 2014. Again, only the trees show any growth.

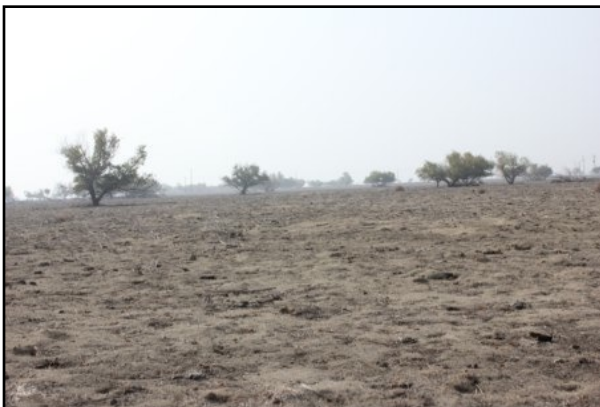
**Photograph 4.** Same area as shown on November 7, 2014. Essentially no growth of herbaceous plants occurred throughout the season.

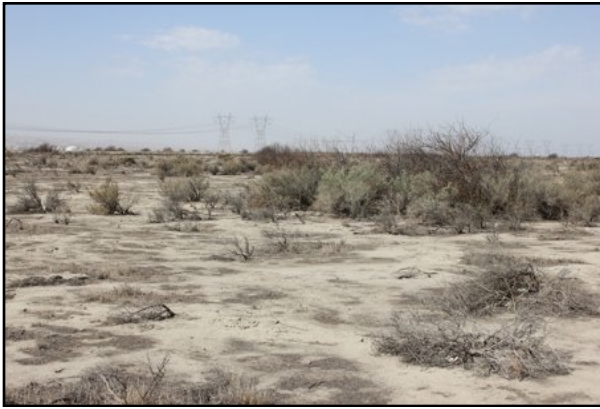
**Photograph 5.** Sensitive habitat sector in the Southeast Area on March 12, 2014. No visible germination or growth of herbaceous plants.

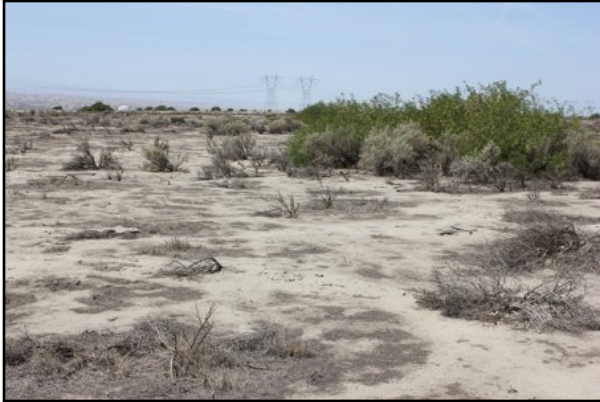
**Photograph 6.** Same area as shown in Photograph 5 on April 23, 2014. The only visible growth is from the honey mesquite and some of the allscale shrubs.

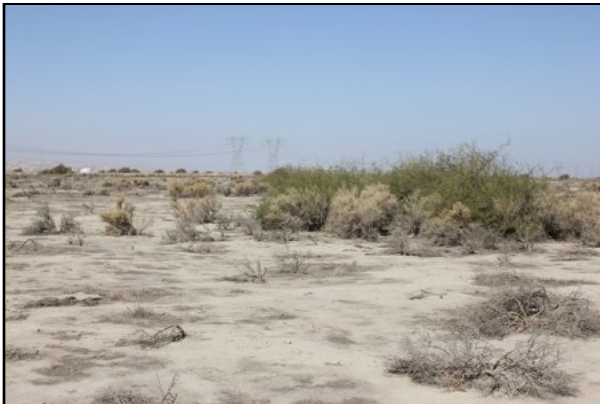
**Photograph 7.** Same area on September 5, 2014. Visibly more growth on some of the allscale shrubs, but even the honey mesquite is losing much of its foliage.

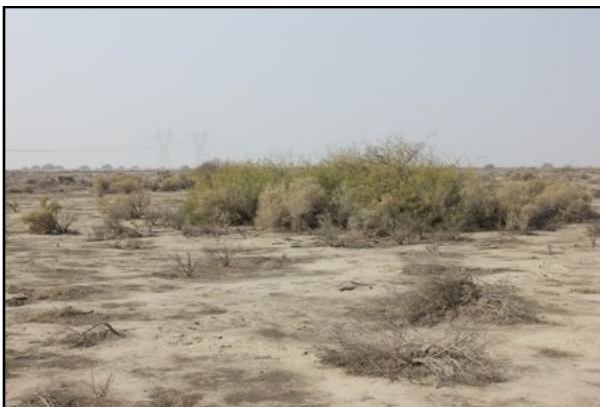
**Photograph 8.** Same area on November 7, 2014. Very little change from what was observed at the site on September 5, 2014.

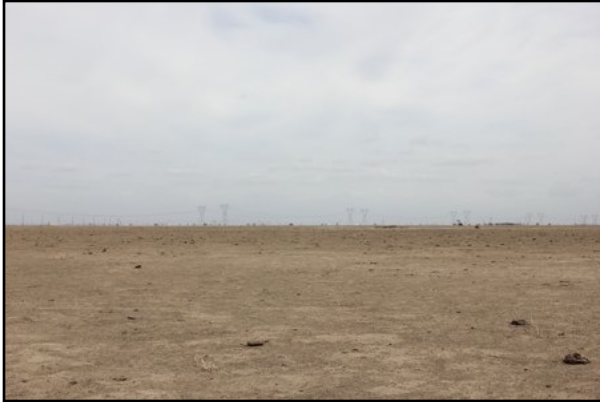
**Photograph 9.** Area within the conservation bank sector of the KWB on March 7, 2014. No germination or growth of any herbaceous plants observed.

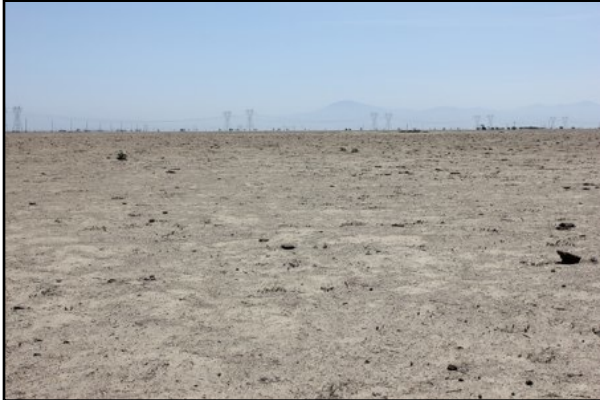
**Photograph 10.** Same area as shown in Photograph 9 on April 23, 2014. Still no visible growth observed, other than some Russian thistle plants are germinating and growing, mostly along the road edges.

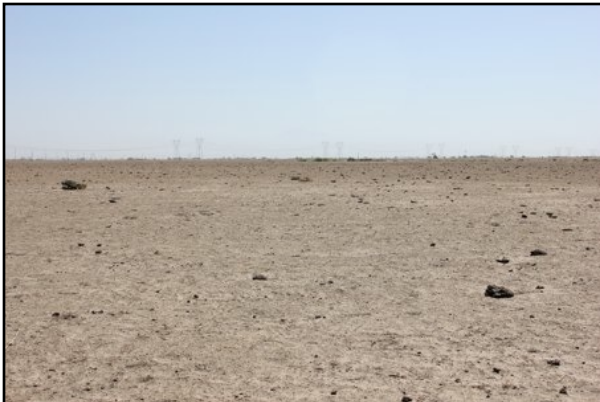
**Photograph 11.** Same area on September 5, 2014. Conditions are similar to what was observed on April 23, 2014.

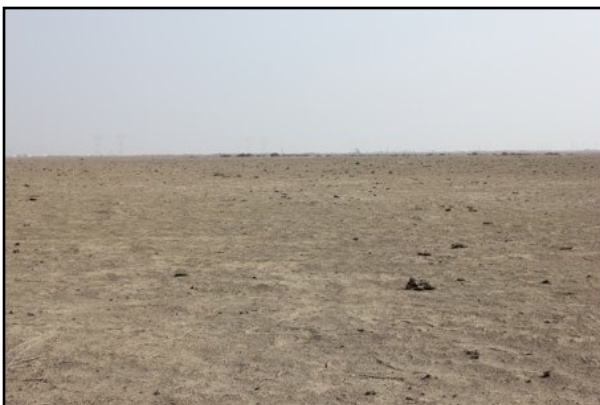
**Photograph 12.** Same area on November 7, 2014. Essentially identical conditions prevailed throughout the year.

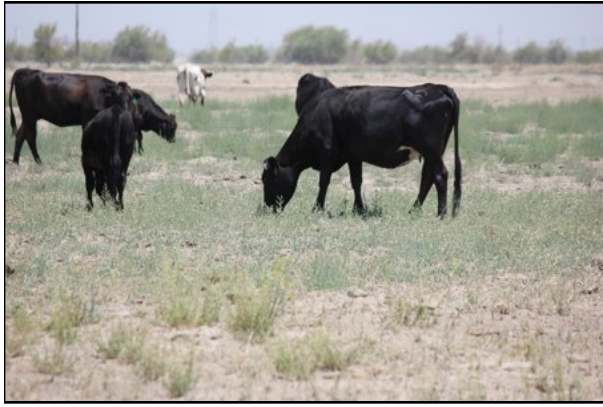
**Photograph 13.** Cattle grazing on Russian thistle in the Strand Area in August of 2014.

A total of 41 AU were returned to the South Area on April 28, 2014. These cattle remained in the South Area for just over a month grazing on Russian thistle until May 31, when all of the cattle were removed. The Strand Area is much larger than the South Area and the Strand Area is probably the most prone to Russian thistle explosions than most of the areas of the KWB. It was decided to try 135 AU in the Strand and these cattle were turned out in March of 2014 with the idea that they would be closely monitored to make sure they were in fact eating the Russian thistle and also that they were not damaging any of the Goodding's willows (*Salix gooddingii*) or other trees. Cattle remained in the Strand Area for the rest of the summer and into the fall. They definitely grazed heavily on the Russian thistle and in many areas cattle also topped the Russian knapweed (*Acroptilon repens*), which is also an undesirable non-native plant that can form dense stands in the summer and fall at the KWB. Photographs 13 - 16 illustrate cattle effectively grazing on Russian thistle Russian knapweed in the South and Strand Areas.

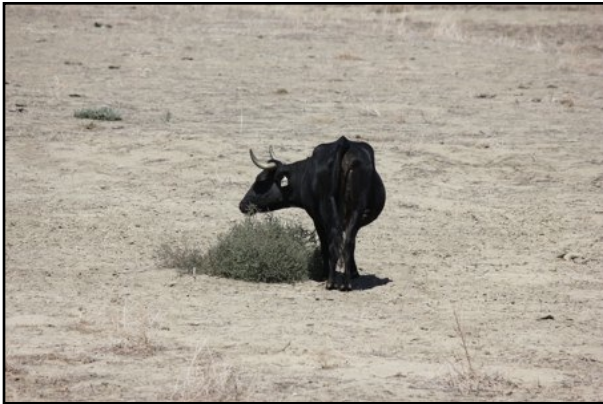
**Photograph 14.** Cow eating a mature tumbleweed within a pond basin.

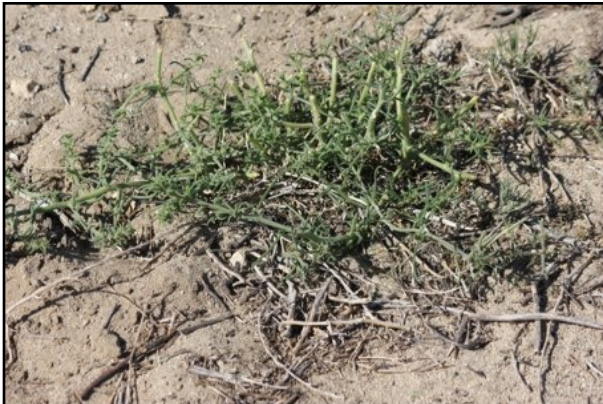
Although cattle definitely grazed the Russian thistle and Russian knapweed, it is difficult to state to what degree the grazing may have been effective at reducing the seed production of these plants. This is largely because the plants were not completely removed by the cattle, rather the cattle appeared to primarily eat the outer portions of

**Photograph 15.** Grazed Russian thistle plant. This was often how the cattle would graze these mature plants, eating down to within a few inches of the ground but not eating the entire plant.

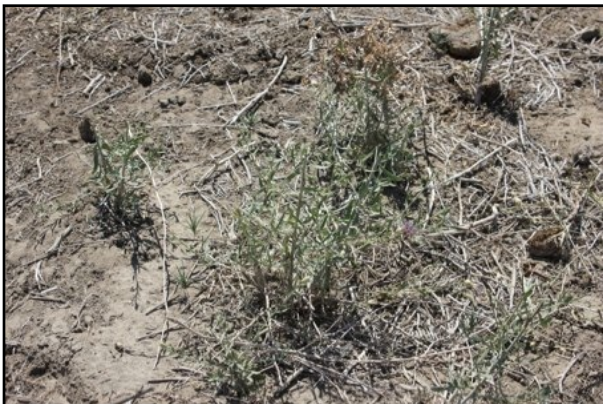
**Photograph 16.** Grazed Russian knapweed plant. Cattle typically only ate the outer margins of knapweed, including the flowers.
