2013 Vegetation Monitoring Program Observation Monitoring Sites and Livestock Grazing Summary for the Kern Water Bank

May 25, 2014

2013 VEGETATION MONITORING PROGRAM
OBSERVATION MONITORING SITES AND LIVESTOCK GRAZING SUMMARY
for the
KERN WATER BANK

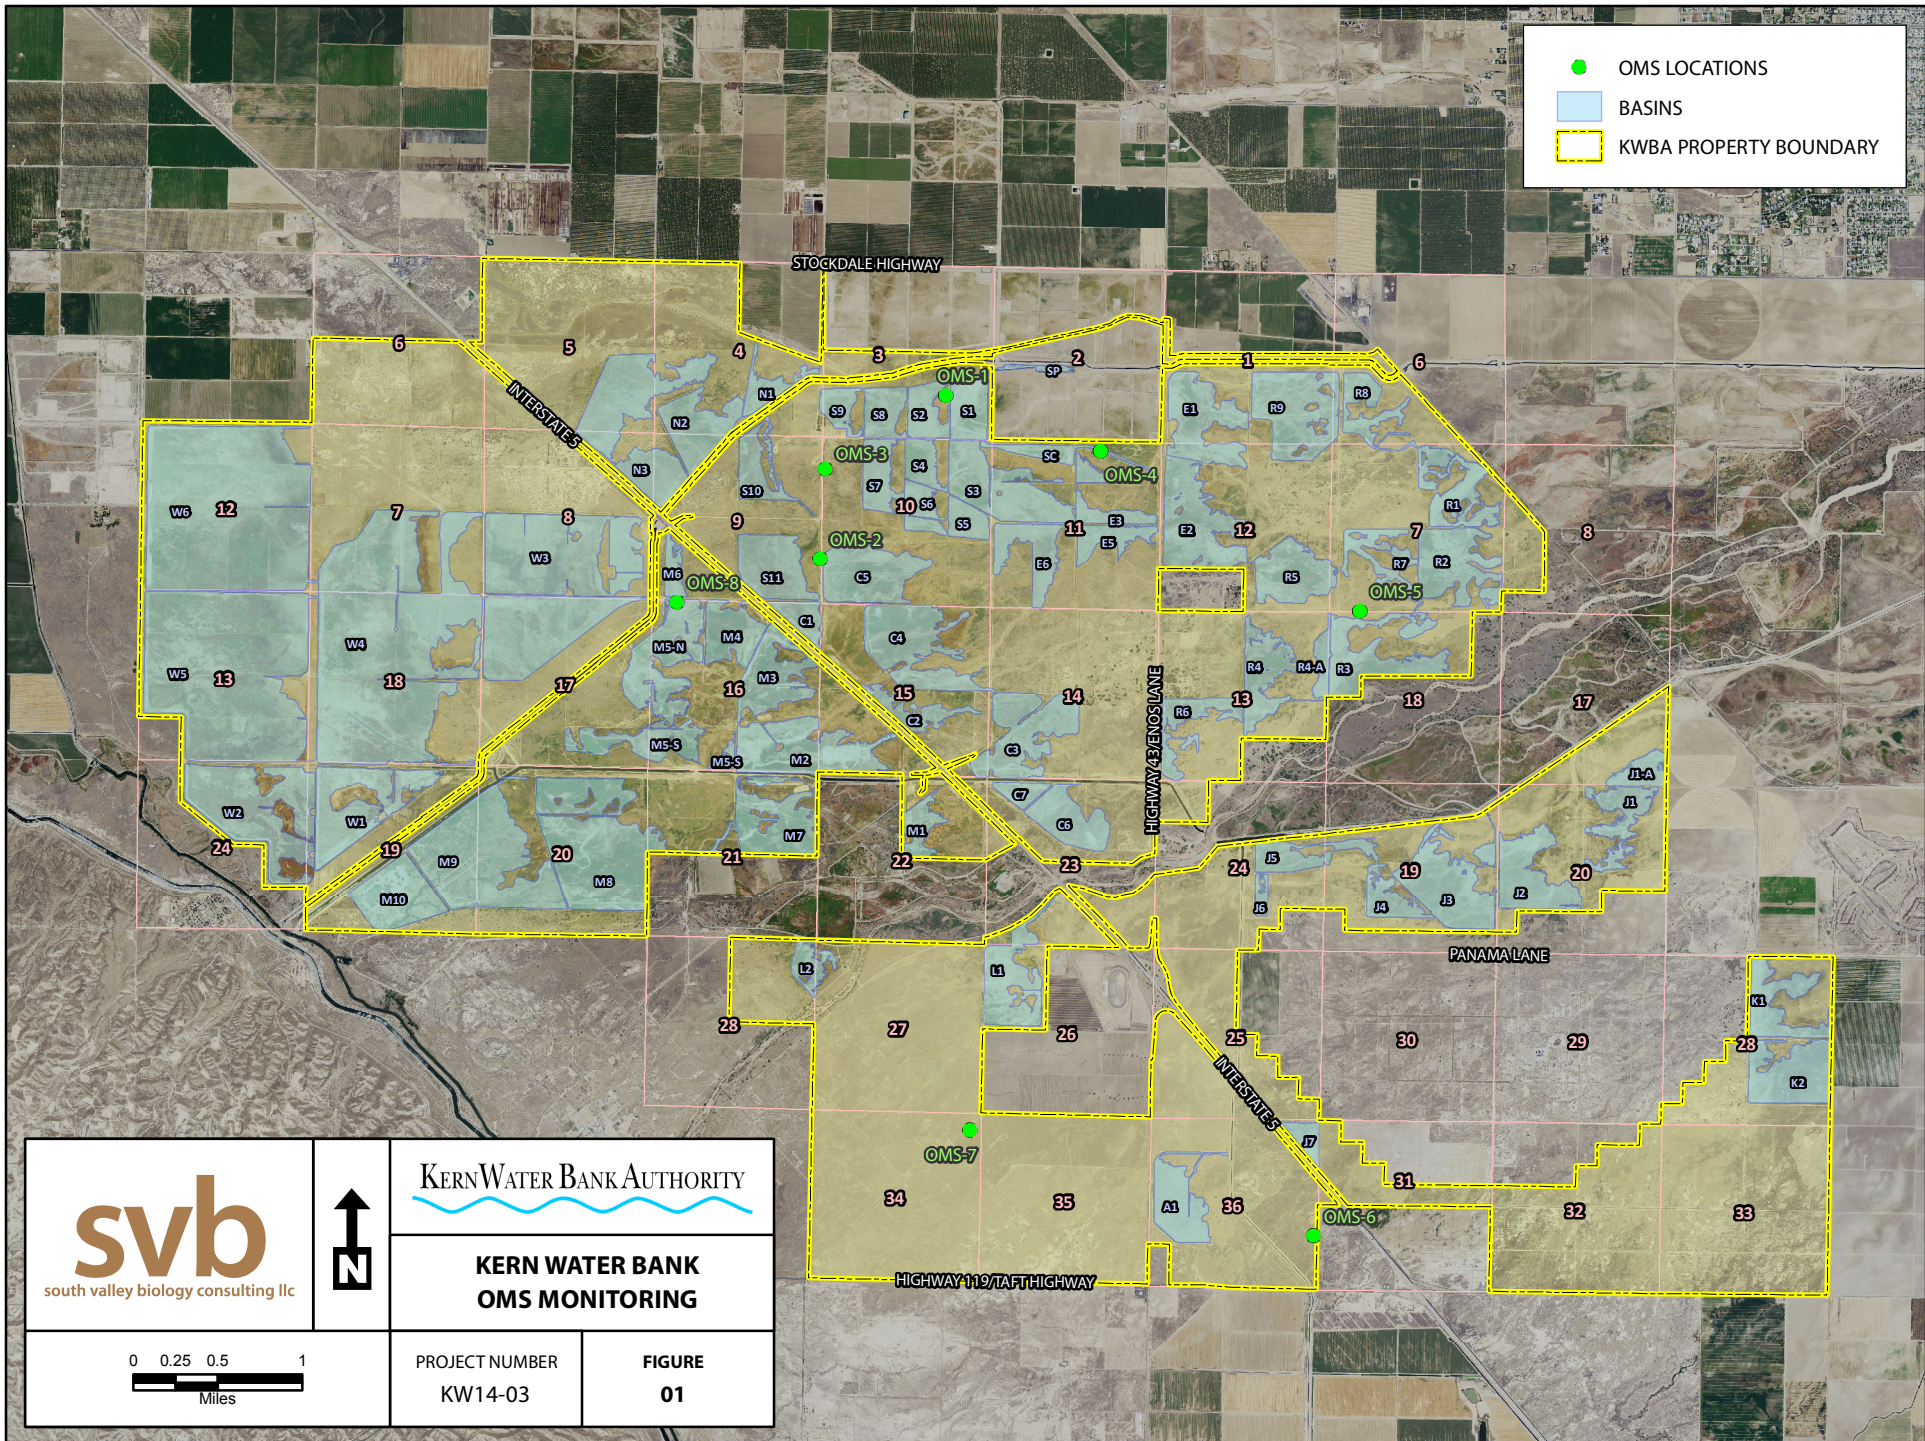
FIGURE
01

- OMS LOCATIONS
- BASINS
- KWBA PROPERTY BOUNDARY

**KERN WATER BANK
OMS MONITORING**

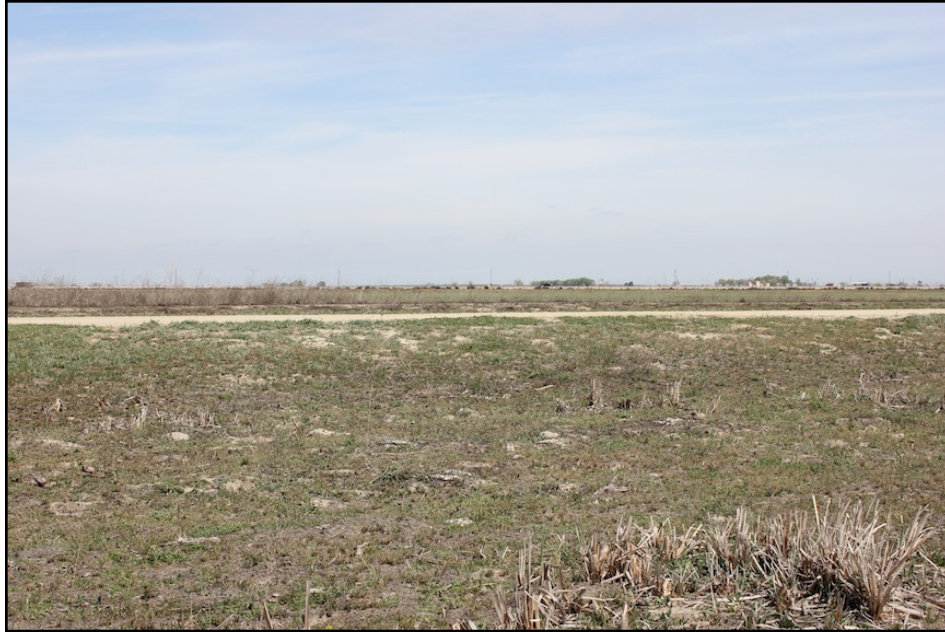
Photograph 1. Herbaceous vegetation in a dry pond basin on March 28, 2013.

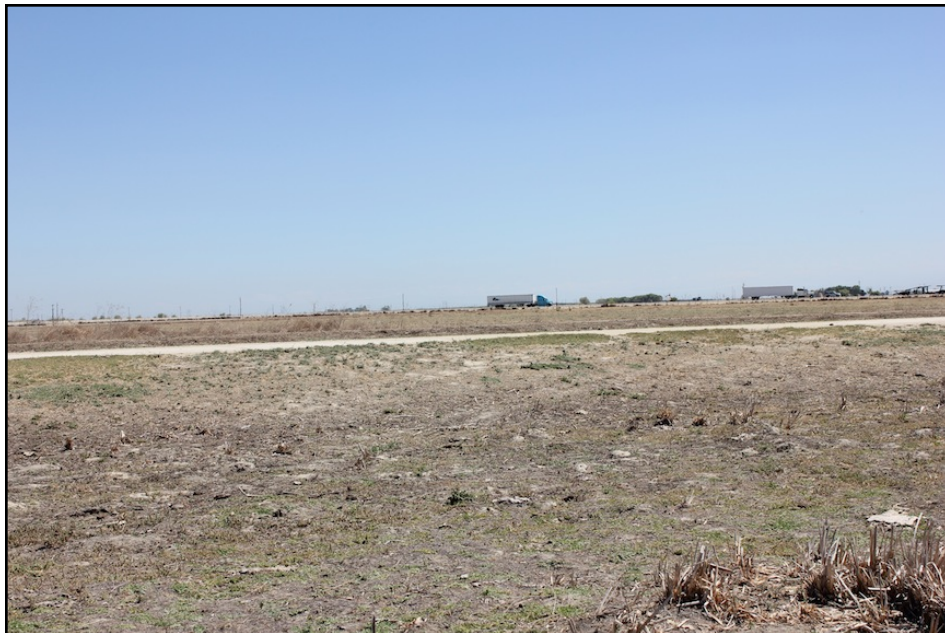
Photograph 2. Same area as shown in Photograph 1 on June 25, 2013. Vegetation did not reach excessively high density and heights from a combination of low rainfall and managed cattle grazing.

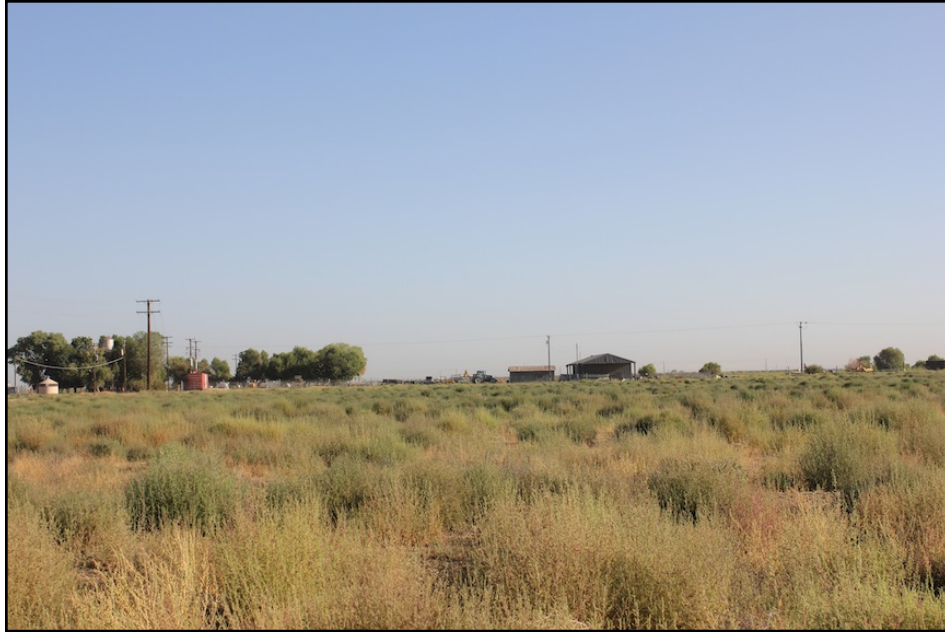
Photograph 3. Heavily infested area with Russian thistle on August 28, 2012. This was a common site in 2012 over much of the KWB.

Rainfall during the 2013 rain year (October 1, 2012 - September 30, 2013) for the KWB was approximately 3.13 inches (48% of normal). This marked the second successive below-average rainfall year. However, unlike what was observed during the 2012 rain year (October 1, 2011 - September 30, 2012) that brought very dry and very cold early conditions in November, December, and January that resulted in very little germination of vegetation, the 2013 rain year brought slightly more rain during the early months when plants are growing. More importantly, there were fewer frost days in 2013 so plants that germinated were not killed by frost. This allowed for early germination and growth of plants (Photograph 1); however, 2013 was very dry for the remainder of the year and vegetation did not become excessively dense (Photograph 2). One positive result of this rain pattern was that it contrasted significantly with the pattern in 2012 where a wet March and April resulted in tremendous Russian thistle (*Salsola tragus*) problems. Although Russian thistle growth did occur in 2013, it was much easier to manage and vegetation management including mowing and cattle grazing helped to lessen the impacts of Russian thistle over much of the KWB (Photographs 3 and 4).

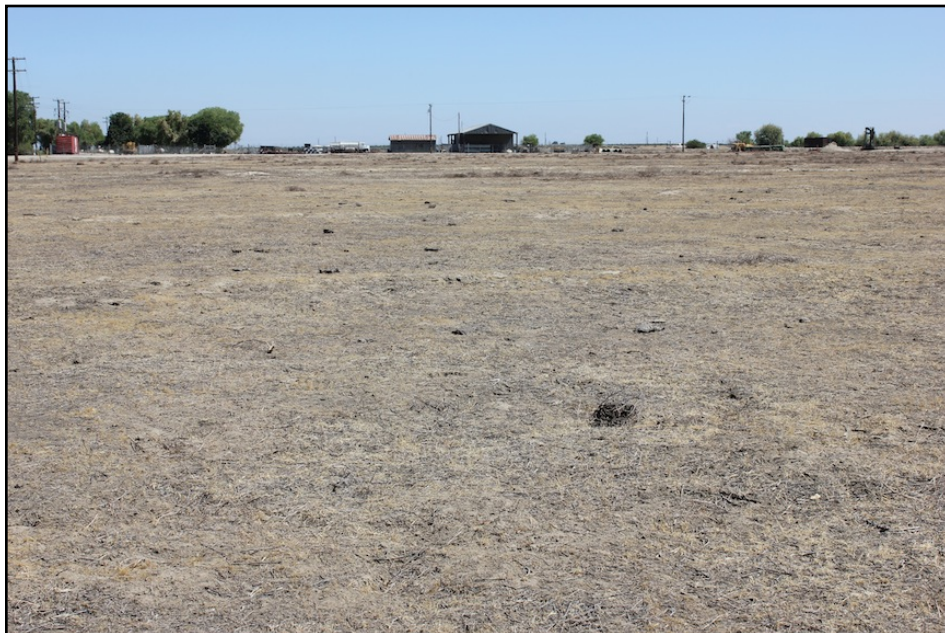
Photograph 4. Same area as shown in Photograph 3 on June 25, 2013. A combination of lower late rains, early cattle grazing, and selected areas of mowing, combined to allow for a much better open habitat over much of the KWB in 2013.

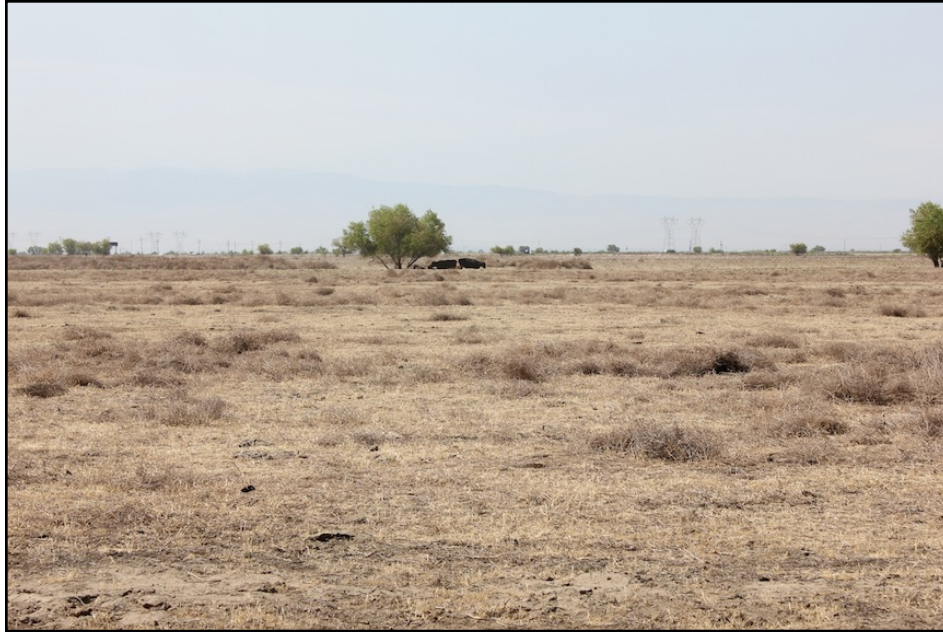
Photograph 5. Cattle grazing in the Strand Area in July 2013. The Strand Area often experiences some of the densest rank vegetation build up. Cattle will eat the dry remains of many of these plants, helping to open the habitat up for native wildlife.

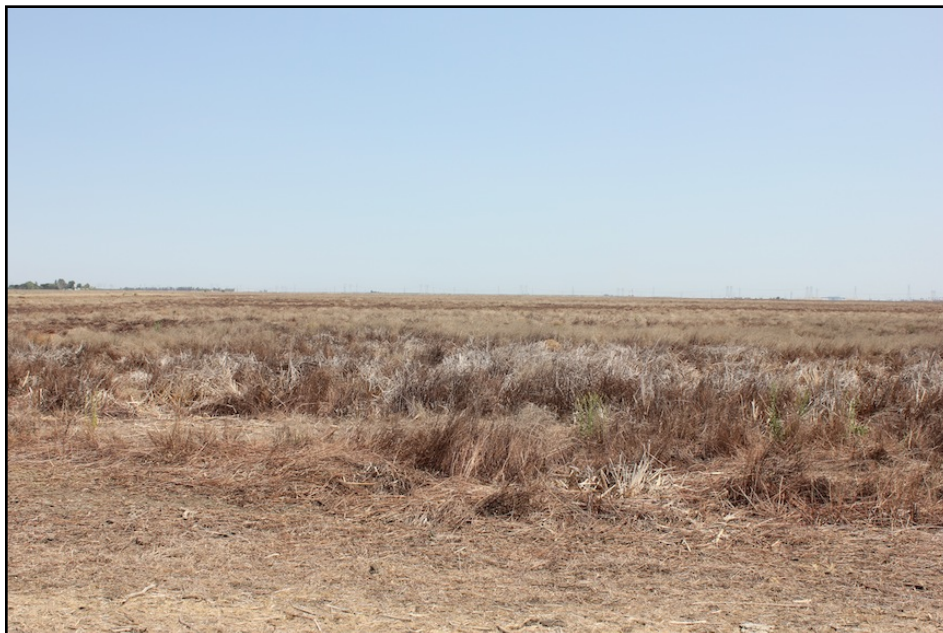
Photograph 6. One of the recharge ponds in the West Area with dense rank vegetation on July 5, 2013. Cattle remained in the West Area throughout the entire season in 2013 in an effort to knock down the dense plants.

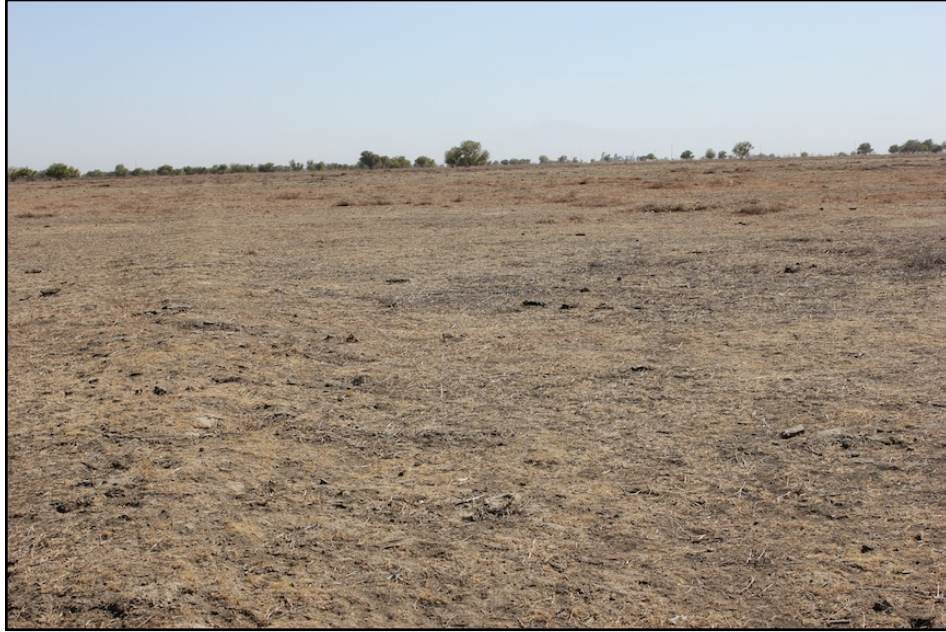
Photograph 7. The Strand Area on September 27, 2013 shortly after cattle grazing had concluded for the season.

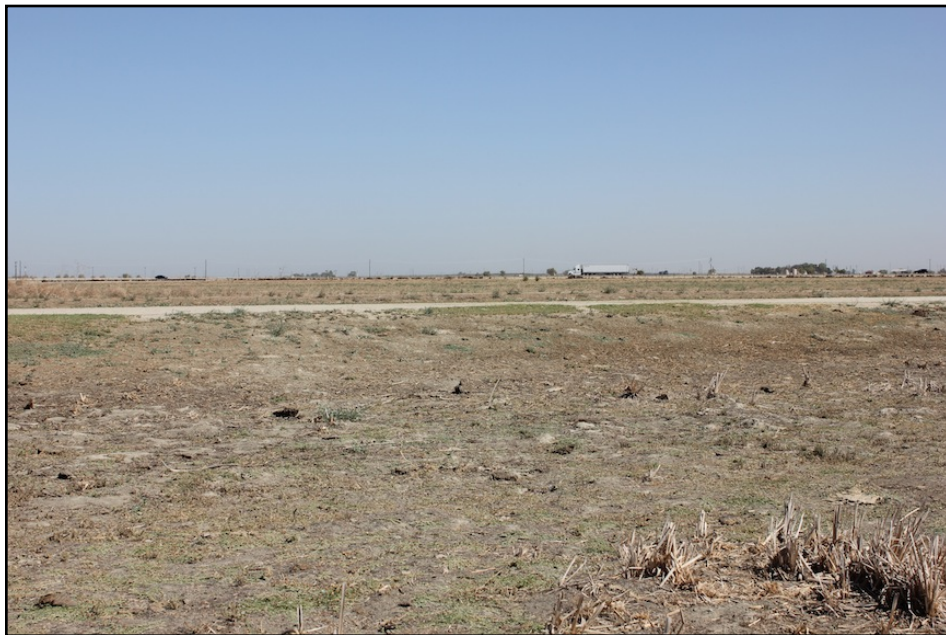
Photograph 8. Pond basin in the Main Area on September 27, 2013. Cattle were removed the following month in October 2013.

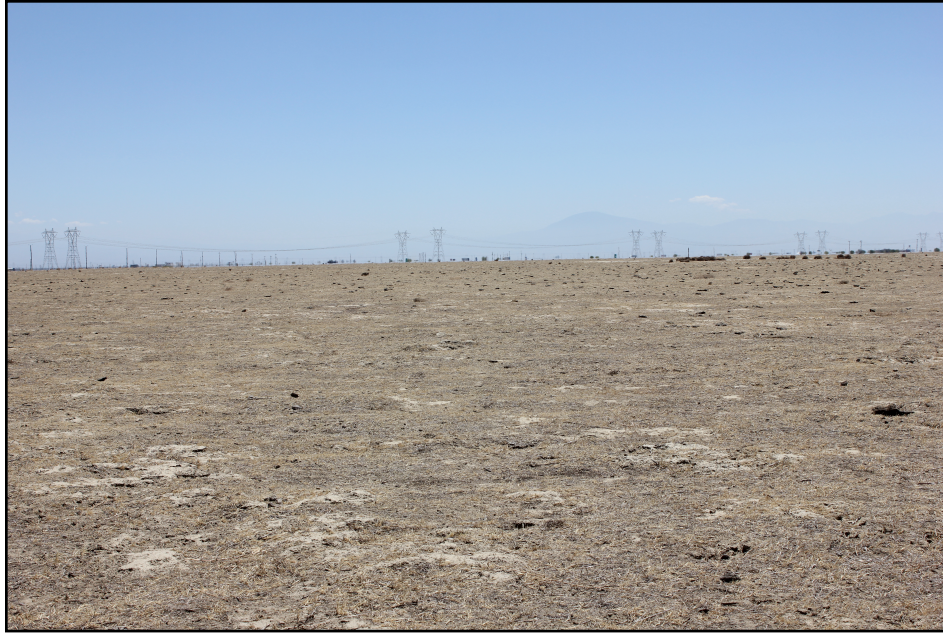
Photograph 9. South Area on June 25, 2013. Only 14 cows and calves were present and all cattle were removed by the middle of September 2013.

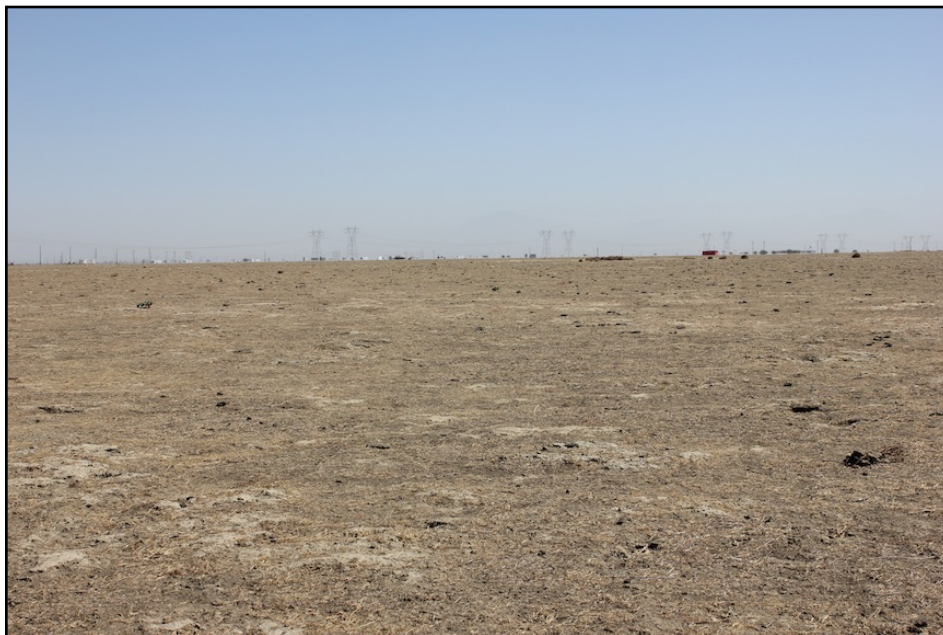
Photograph 10. Same area as shown in Photograph 9 on September 27, 2013, just after cattle were removed.

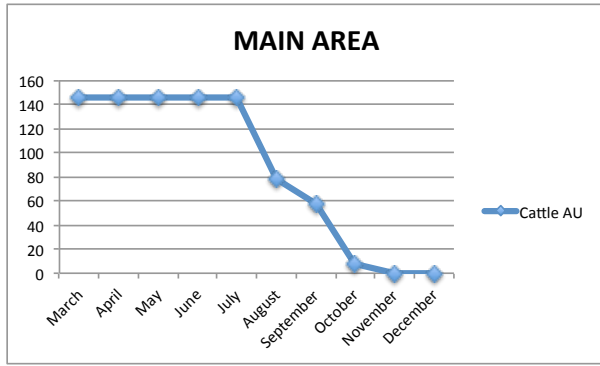
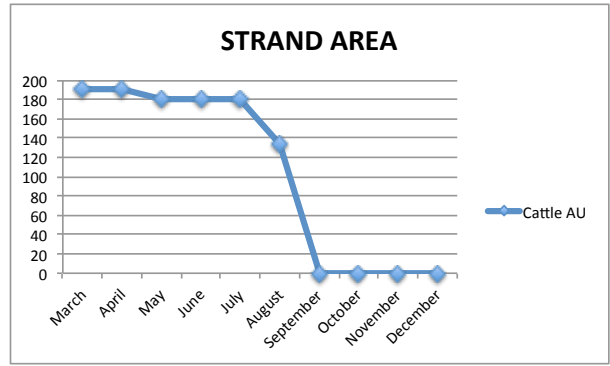
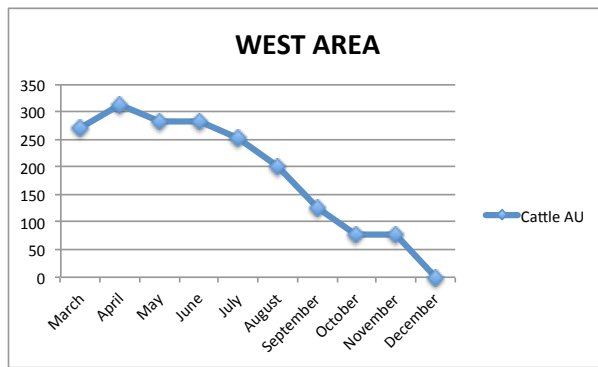
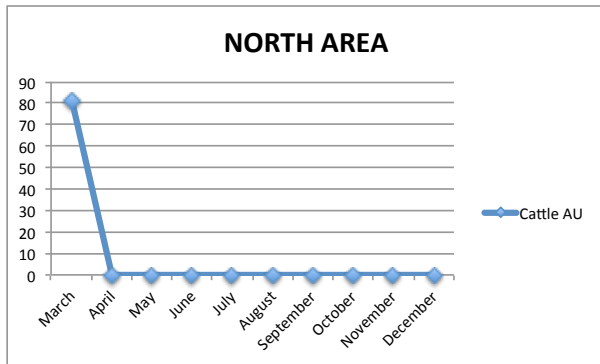
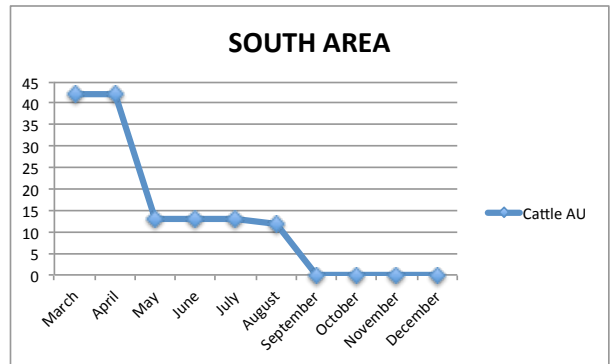
Figure 2. Charts showing the number of cattle, expressed as an Animal Unit (AU) which is one adult cow and one calf, that were present in each area by month during 2013.

It was determined that for the areas that were being grazed (i.e., the North, West, Strand, Main, and South Areas), the current grazing levels appeared to be appropriate and no significant changes would likely be needed for several weeks in the Main, West and Strand Areas, as these areas still had abundant rank vegetation present, especially in some of the recharge basins (Photographs 5 and 6). However, cattle would need to be removed in the coming weeks from the North Area and cattle numbers would need to be reduced sharply in the South Area. Photographs 7 - 10 help illustrate conditions in some of the areas at or near the conclusion of the grazing season. Figure 2 illustrates the number of cattle, expressed in Animal Units or AU (an AU is one adult cow and one calf), that were present in an area for each month in 2013.

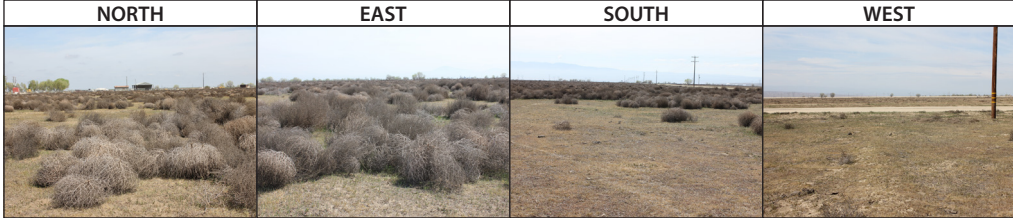
1ST QUARTER	<p> SURVEY DATE: 03/28/2013 TIME: 12:00 PM MONITOR(S): J. JONES RAINFALL TO DATE: 3.03 IN WIND DIRECTION: W WIND VELOCITY: 5 MPH TEMPERATURE: 76 F HUMIDITY: 42% </p> <p> NOTES: NO NEW TUMBLEWEED AT THIS TIME, MANY OLD TUMBLEWEED FROM LAST YEAR STANDING, FEW SCATTERED KANGAROO RAT BURROWS WILDLIFE PRESENT: ROADRUNNER PLANTS PRESENT: BROMUS RUBENS, ERODIUM CICUTARIUM, HIRSCHFELDIA INCANA, HORDEUM MURINUM SSP. LEPORINUM, LASTHENIA CALIFORNICA, SCHISMUS ARABICUS, SISYMBRIUM IRIO </p>	NORTH	EAST	SOUTH	WEST

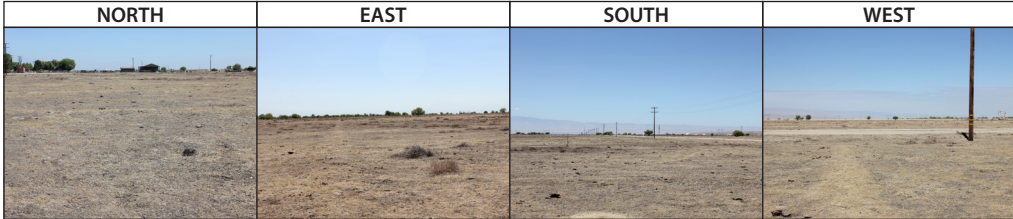
2ND QUARTER	<p> SURVEY DATE: 06/25/2013 TIME: 10:30 AM MONITOR(S): J. JONES, Z. BRISCO RAINFALL TO DATE: 3.13 IN WIND DIRECTION: N WIND VELOCITY: 5 MPH TEMPERATURE: 73 F HUMIDITY: 20% </p> <p> NOTES: DEAD TUMBLEWEED DRIFTS. SITE HAS BEEN MOWED SINCE LAST QUARTER. KANGAROO RAT BURROWS PRESENT WILDLIFE PRESENT: PLANTS PRESENT: BROMUS RUBENS, SCHISMUS ARABICUS </p>	NORTH	EAST	SOUTH	WEST

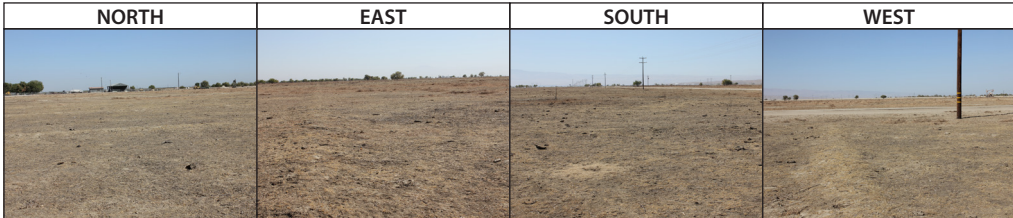
3RD QUARTER	<p> SURVEY DATE: 09/27/2013 TIME: 11:00 AM MONITOR(S): J. JONES RAINFALL TO DATE: 3.13 IN WIND DIRECTION: NW WIND VELOCITY: 8 MPH TEMPERATURE: 70 F HUMIDITY: 29% </p> <p> NOTES: MOSTLY SMALL, DRY SCHISMUS AND BARE GROUND. SPARSE KANGAROO RAT BURROWS WILDLIFE PRESENT: BLACK PHOEBE, MOURNING DOVE, SIDE-BLOTCHED LIZARD PLANTS PRESENT: ERODIUM CICUTARIUM, HIRSCHFELDIA INCANA, HORDEUM MURINUM SSP. LEPORINUM, SCHISMUS ARABICUS </p>	NORTH	EAST	SOUTH	WEST

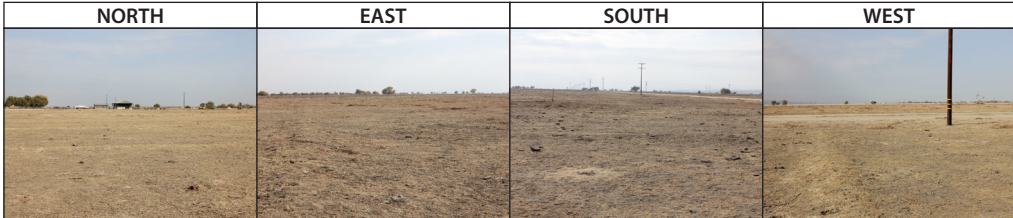
4TH QUARTER	<p> SURVEY DATE: 11/15/2013 TIME: 10:10 AM MONITOR(S): J. JONES RAINFALL TO DATE: 0.97 IN WIND DIRECTION: N WIND VELOCITY: 5 MPH TEMPERATURE: 68 F HUMIDITY: 40% </p> <p> NOTES: DEAD TUMBLEWEEDS. CHOPPING & GRAZING HAS OPENED UP THE SITE. ACTIVE KANGAROO RAT BURROWS WILDLIFE PRESENT: RAVEN PLANTS PRESENT: SALSOLA TRAGUS, SCHISMUS ARABICUS </p>	NORTH	EAST	SOUTH	WEST
